G503 WWII Military Jeep Radiator Rebuild Restore WW2 Restoration

This article shows a step by step process of restoring your G503 WWII Jeep Radiator - By Lew Ladwig

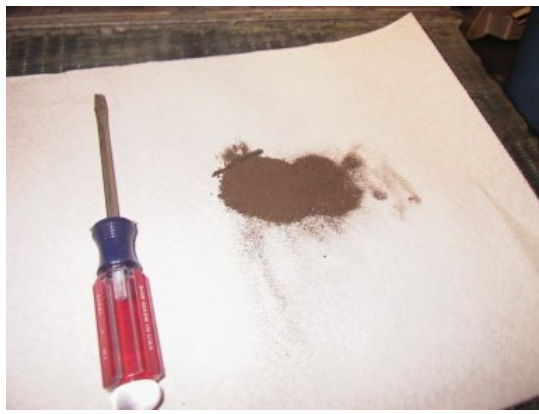
This is about 1/3 of the dirt from the bottom tank:
